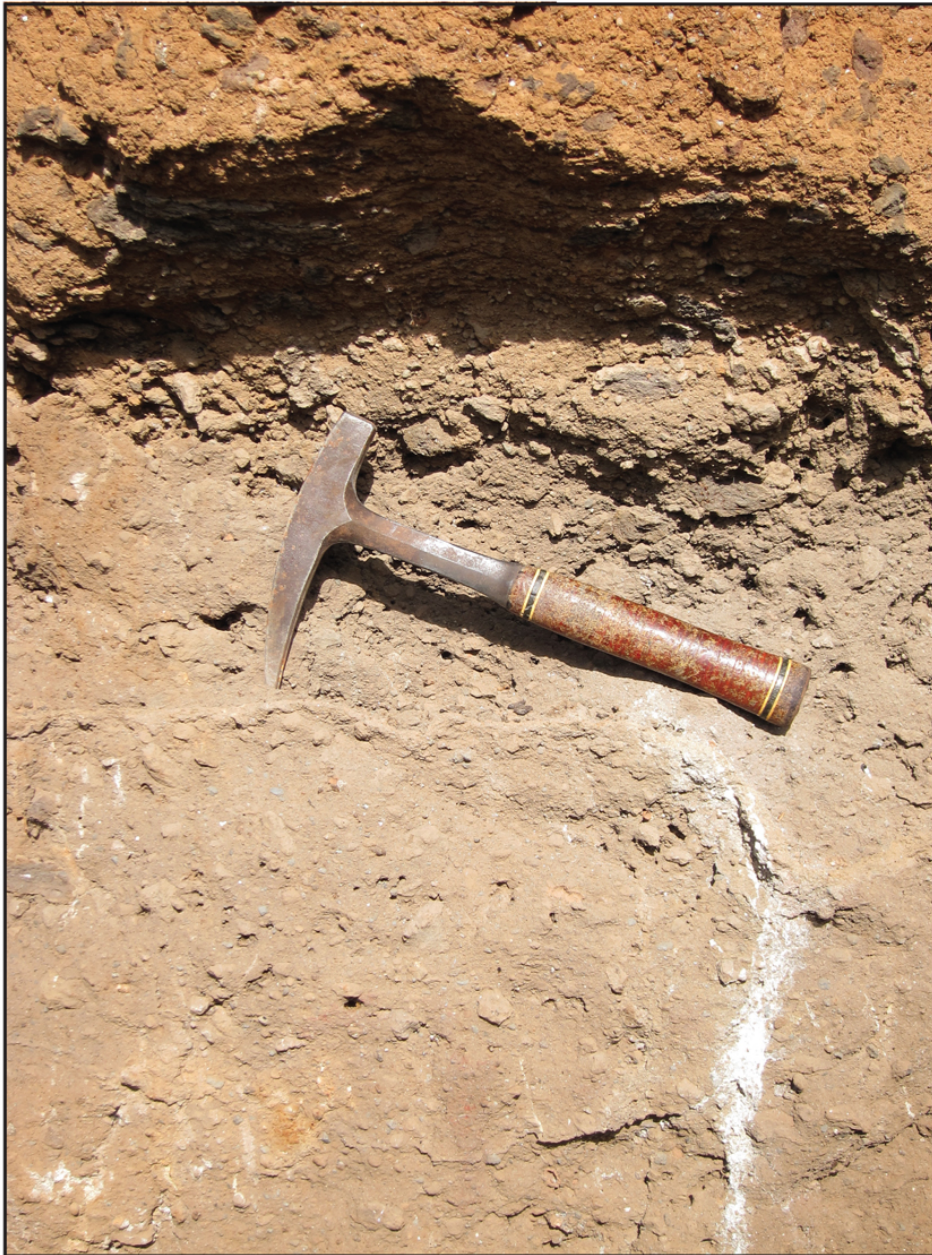
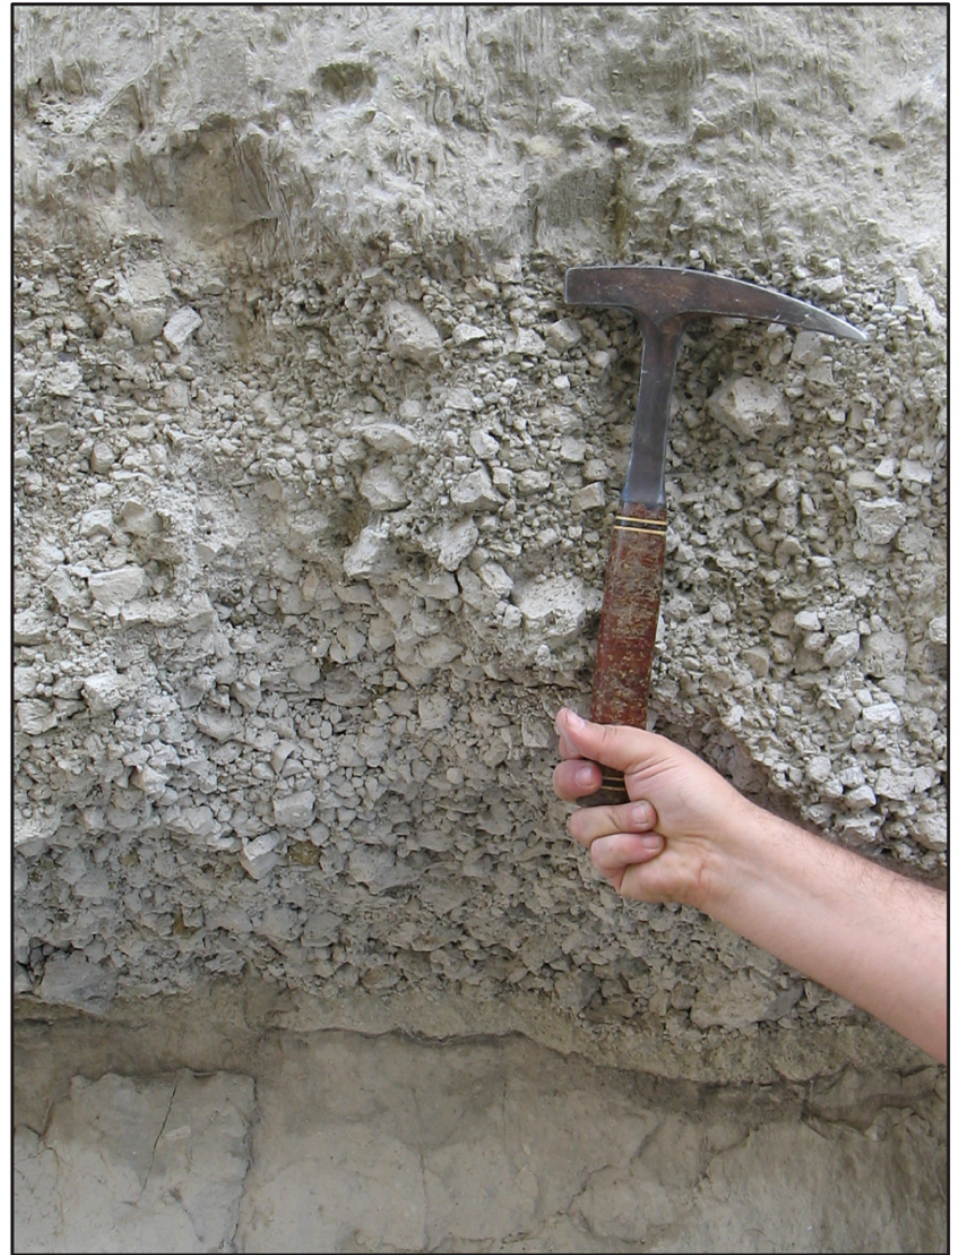
Web Figure 2. Photos of volcanic ash. Left: Pozzolane Rosse deposits from the Colli Albani at Rome. Right: Monte Procida deposits on the Bay of Naples. .

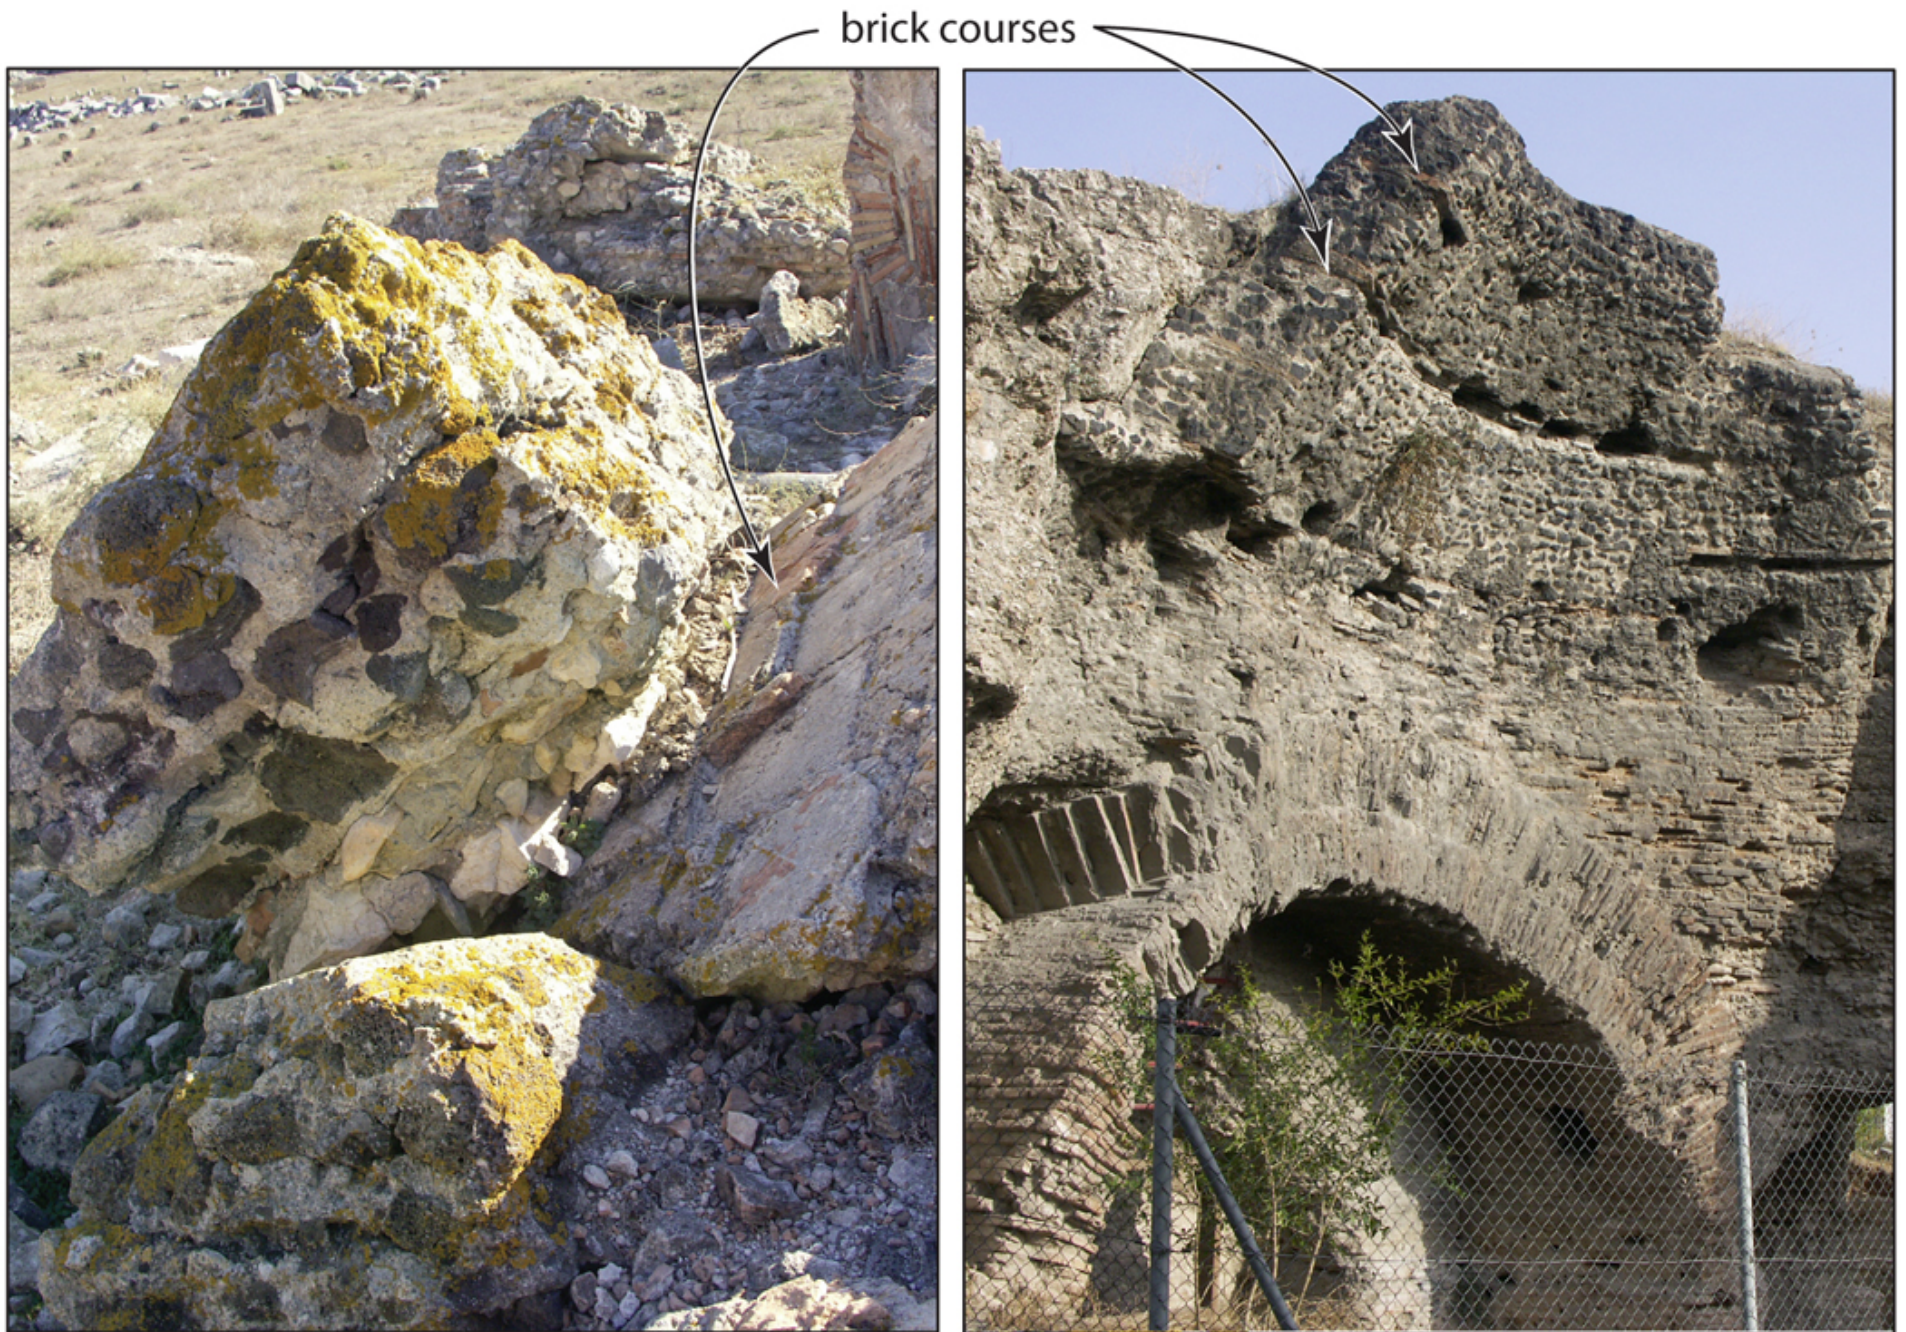
Web Figure 3. Vaults in Smooth Cilicia with volcanic scoria and brick courses. Left: North Baths at Anazarbus. Right: Baths at Tarsus.

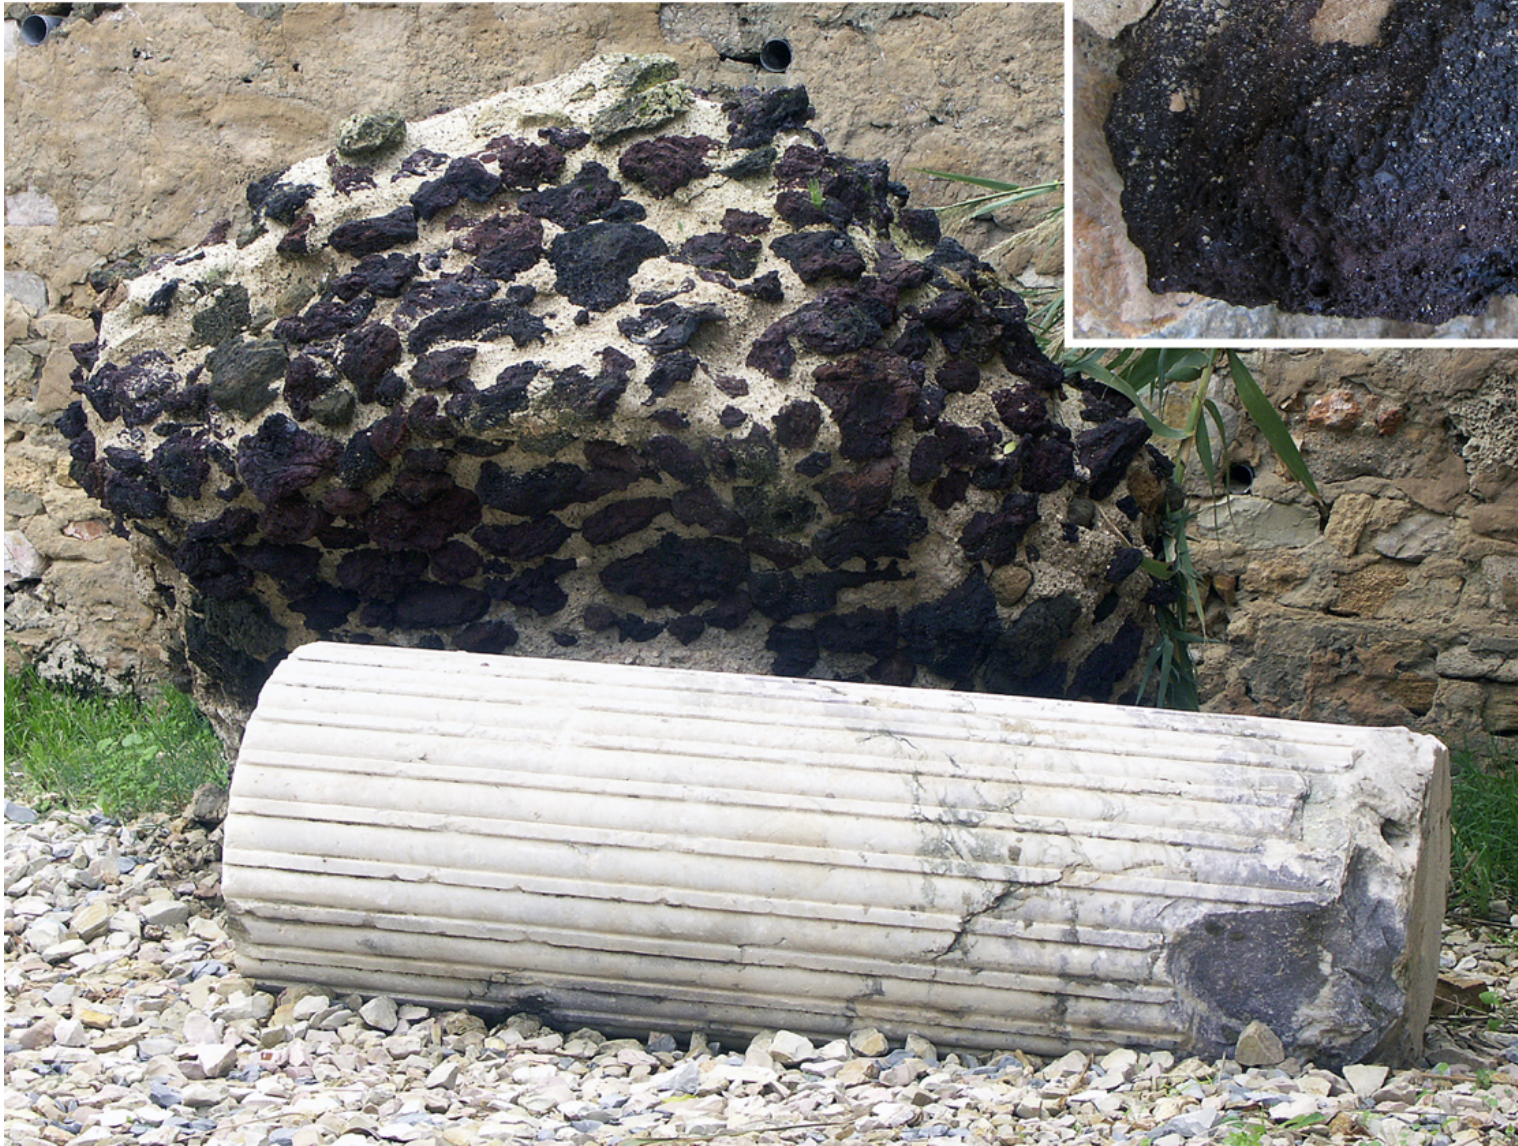
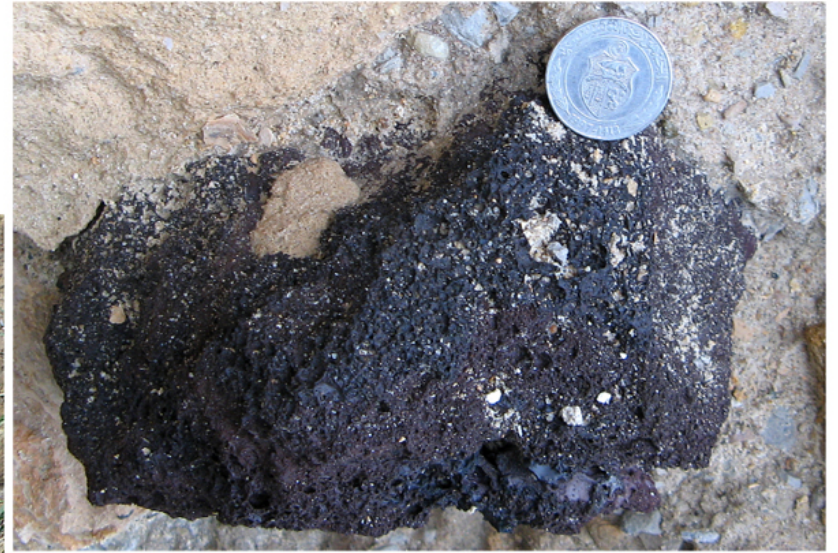
Web Figure 4 (=Figure 10A). Antonine Baths at Carthage (146-162 CE). Chunk of fallen vaulting with *caementa* of dark volcanic scoria imported from Sardinia. Upper right: Detail of scoria.

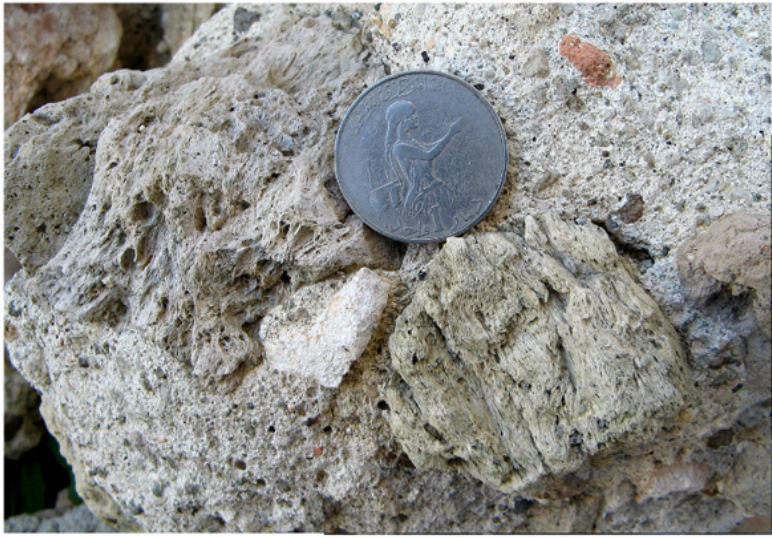
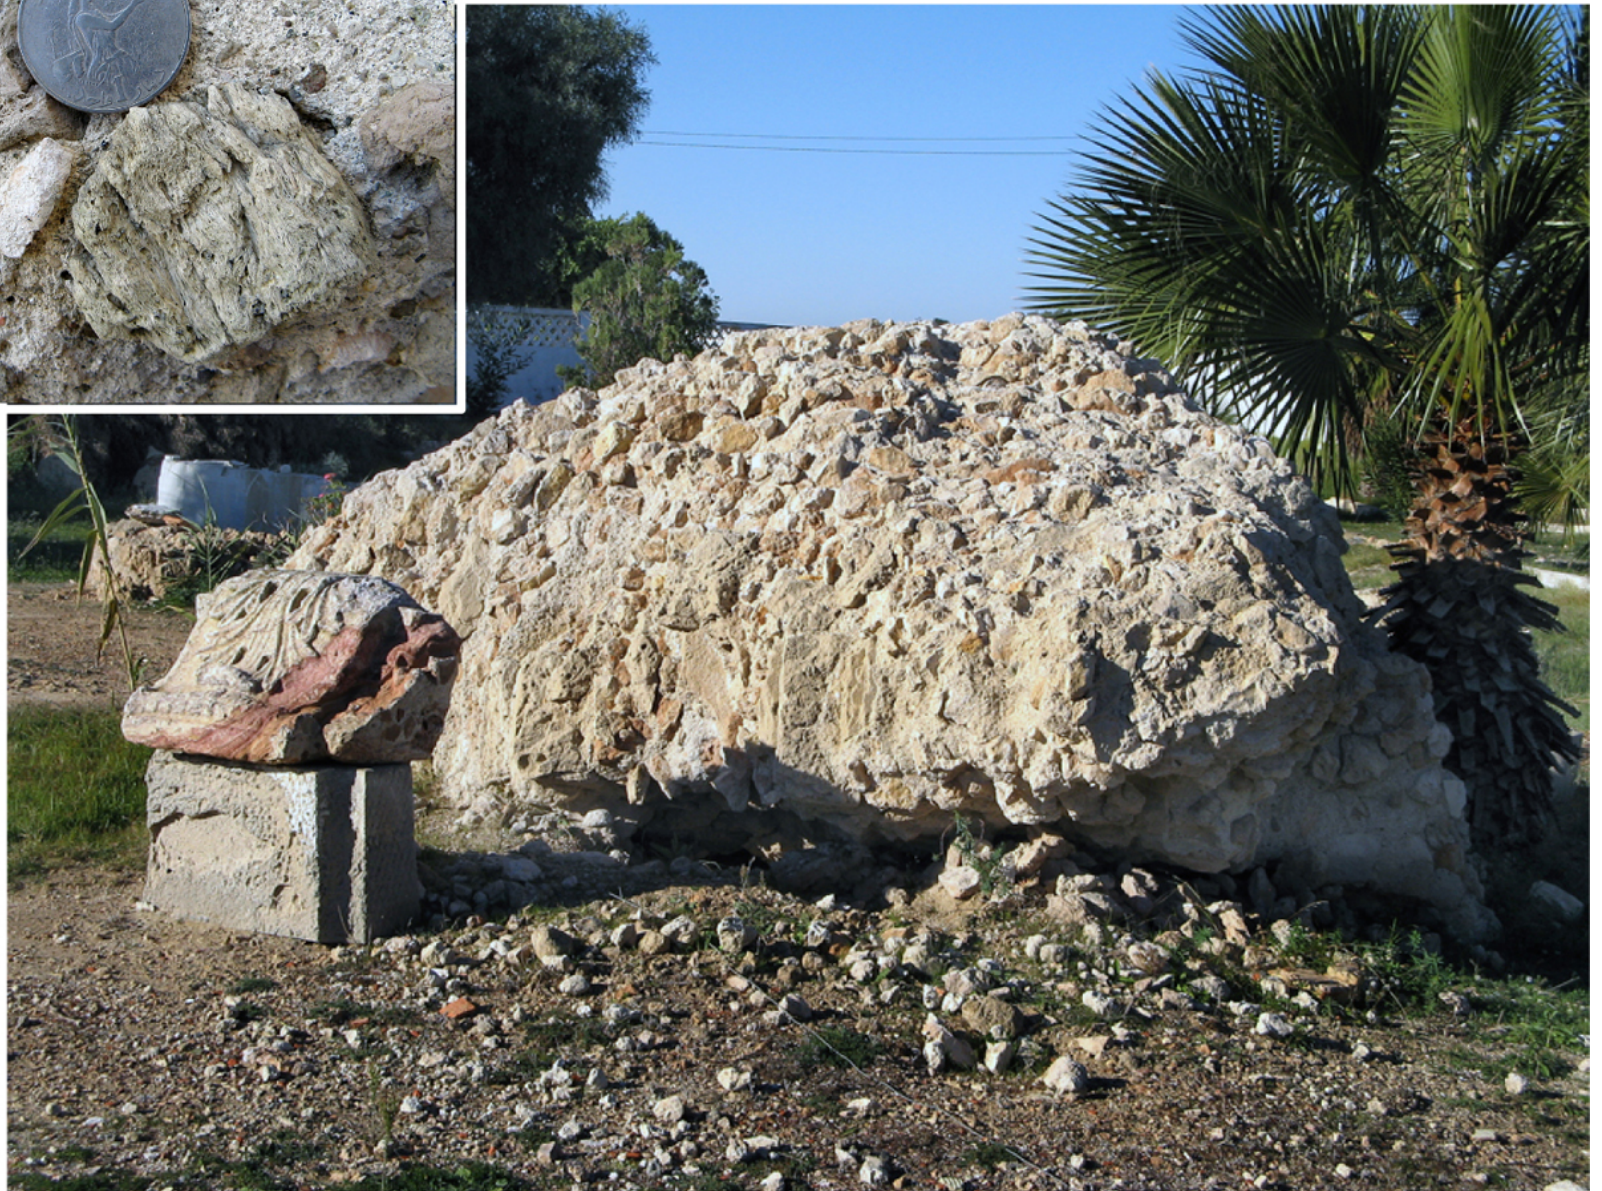
Web Figure 5 (=Figure 10B). East Baths at Leptiminus, Tunisia (late second century CE). Chunk of fallen vaulting with admixture of light colored pumice imported from Pantelleria.

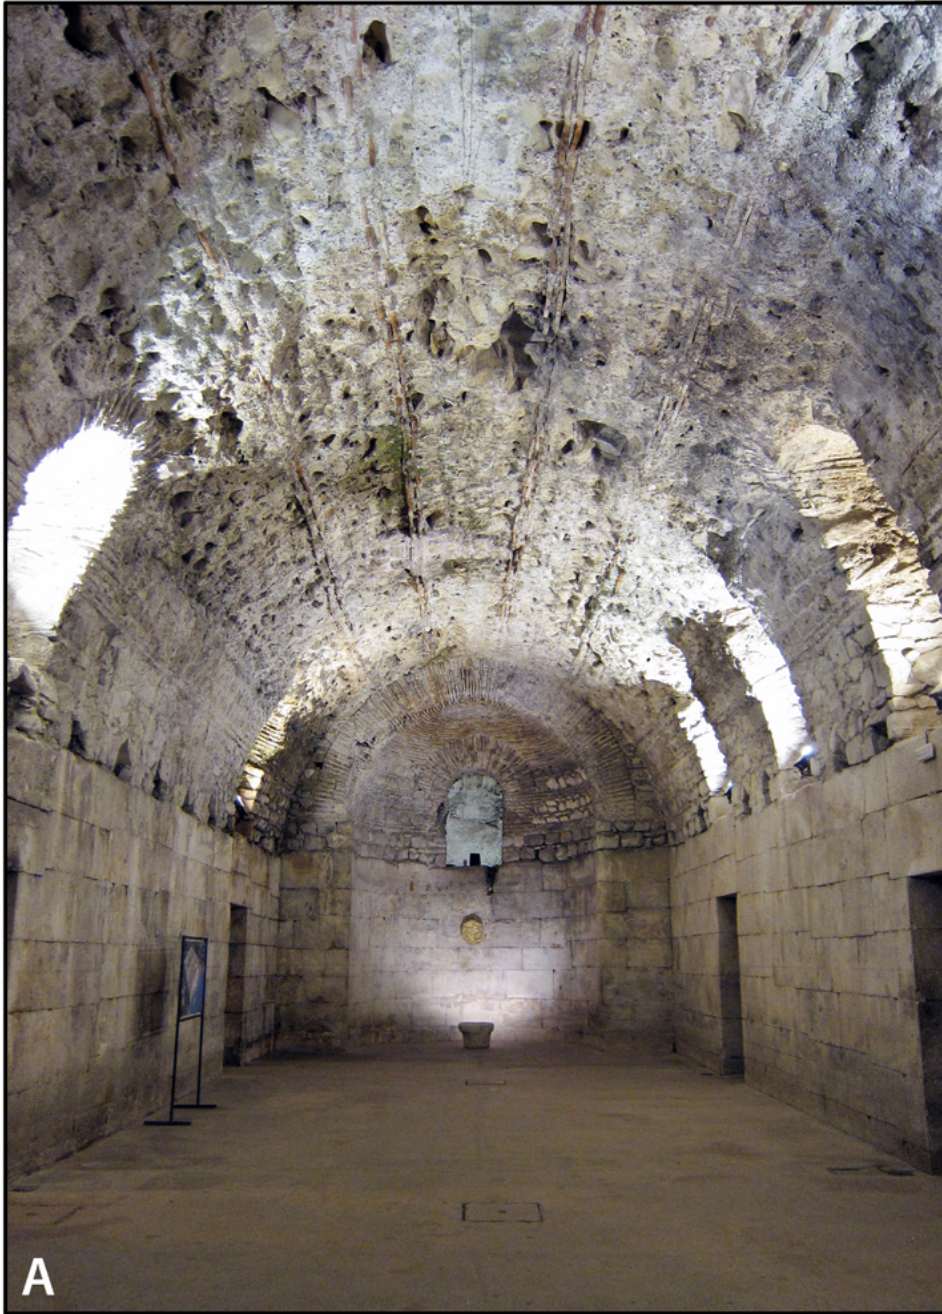
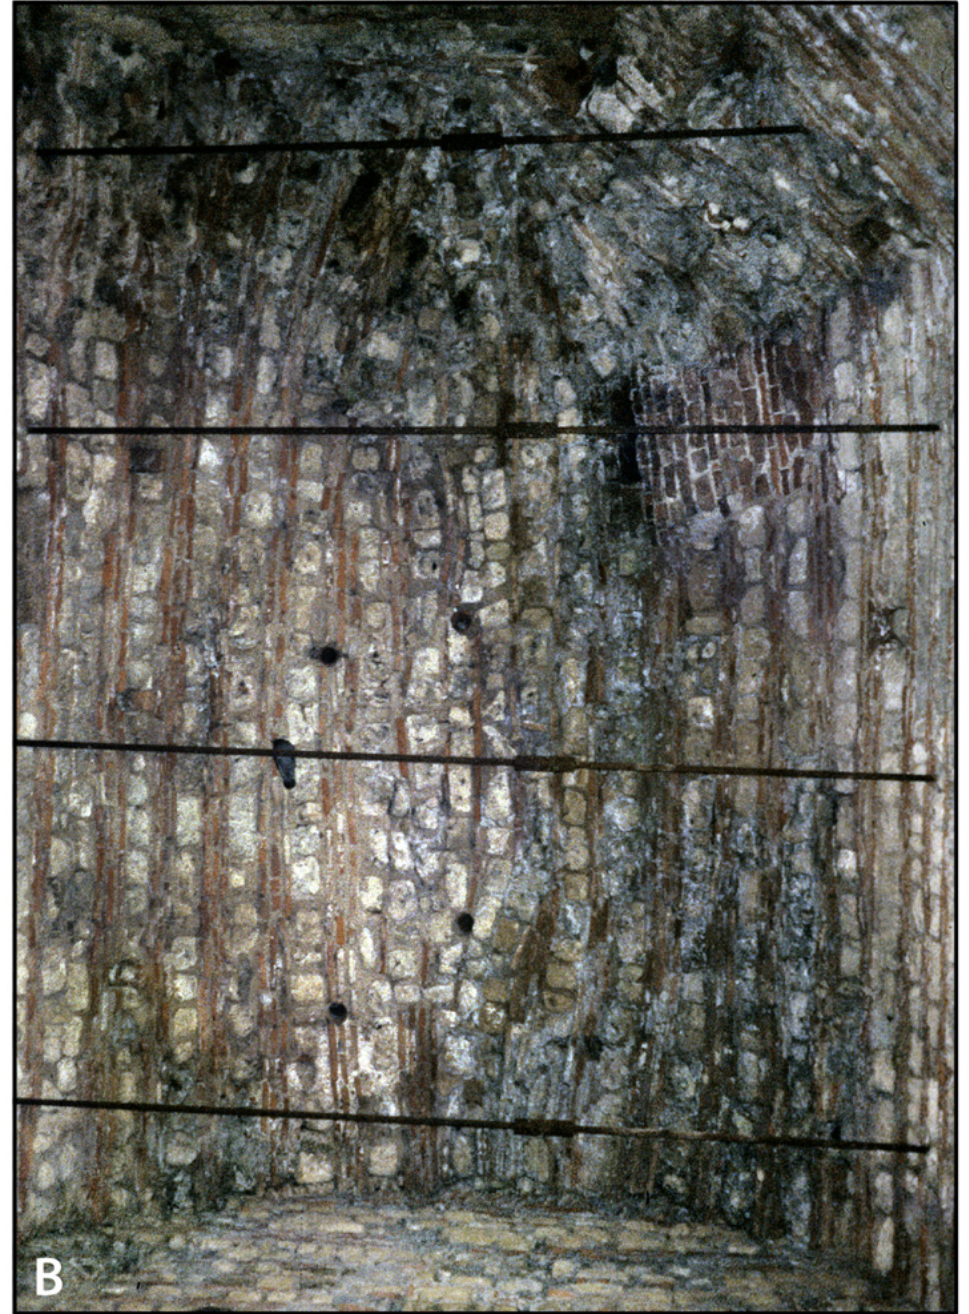
Web Figure 6 (=Figure 13). Examples of radially laid *caementa* combined with courses of radially laid brick. A: Substructures of the Palace of Diocletian at Split, Croatia (c. 305 CE). B: *Praefurnium* for *caldarium* of the Imperial Thermae at Trier, Germany (early fourth century CE). Note vertical tubes in vault for ventilation. The iron tie bars are modern.

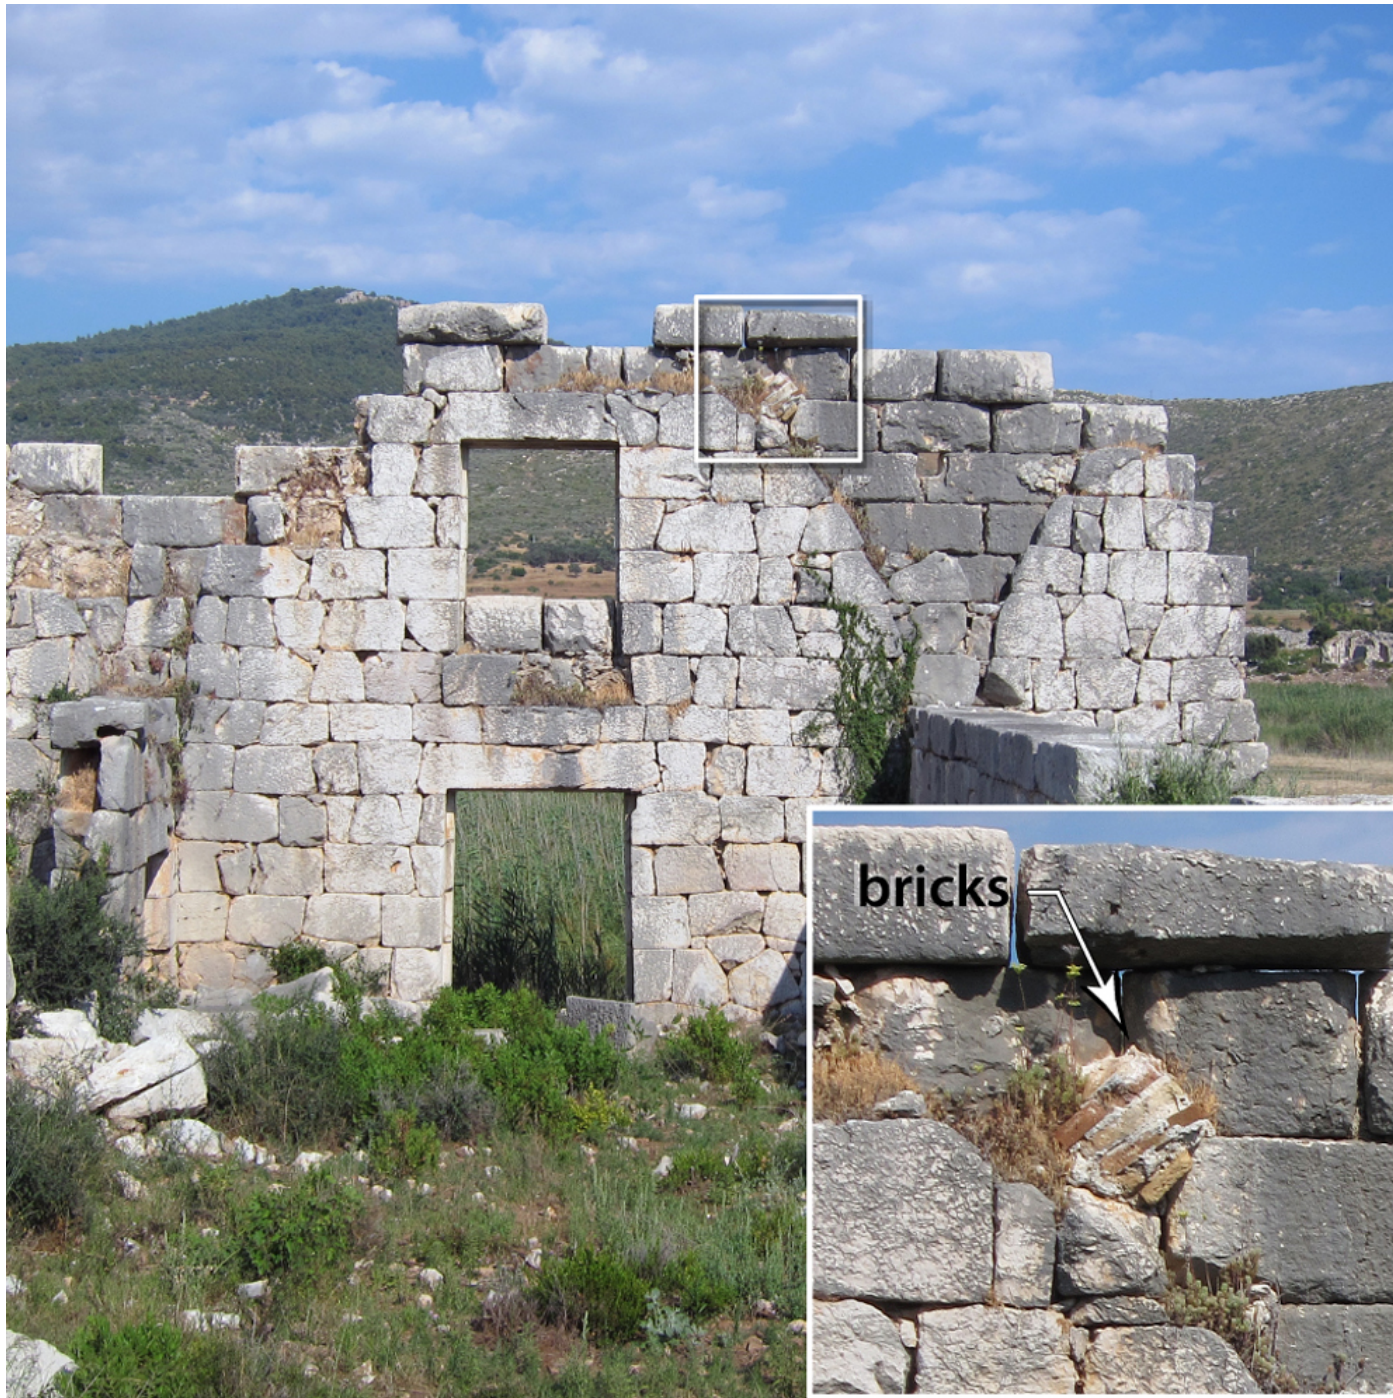
Web Figure 7 (=Figure 20). Hadrianic *Horrea* at Patara. Turkey (129 CE). Inset shows a few radial bricks that remain in the grooves carved into the front wall.

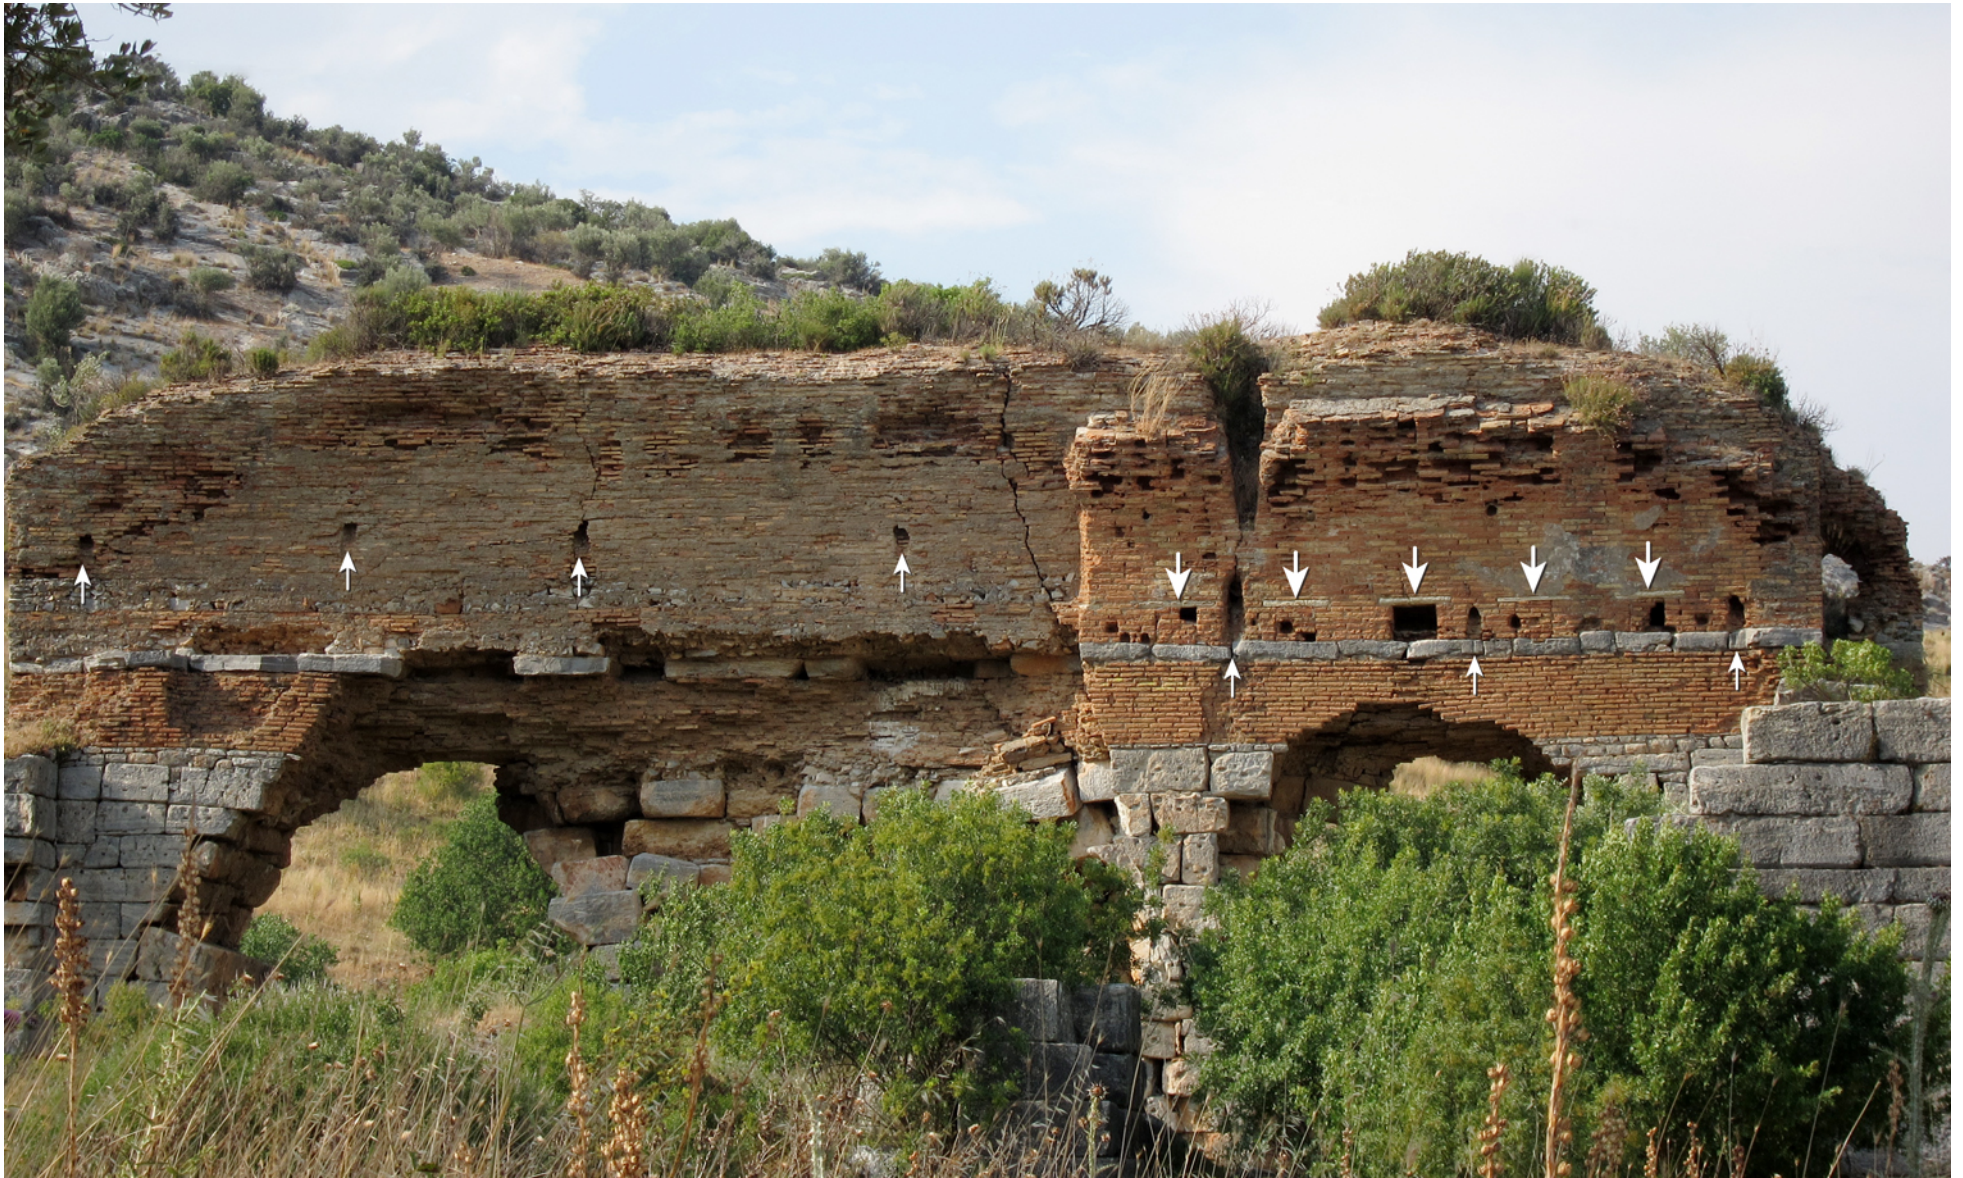
Web Figure 9. East Baths at Ephesus, Turkey (compare Figure 23A). Remains of the *caldarium* vault. Right side shows preserved remains of intrados of the barrel vault with the beam holes (large downward arrows), only one of which is not infilled with brick). The small upwards arrows indicate the locations of the vertical exhaust flues. Left side shows the second ring of brick where the intrados layer has fallen away.

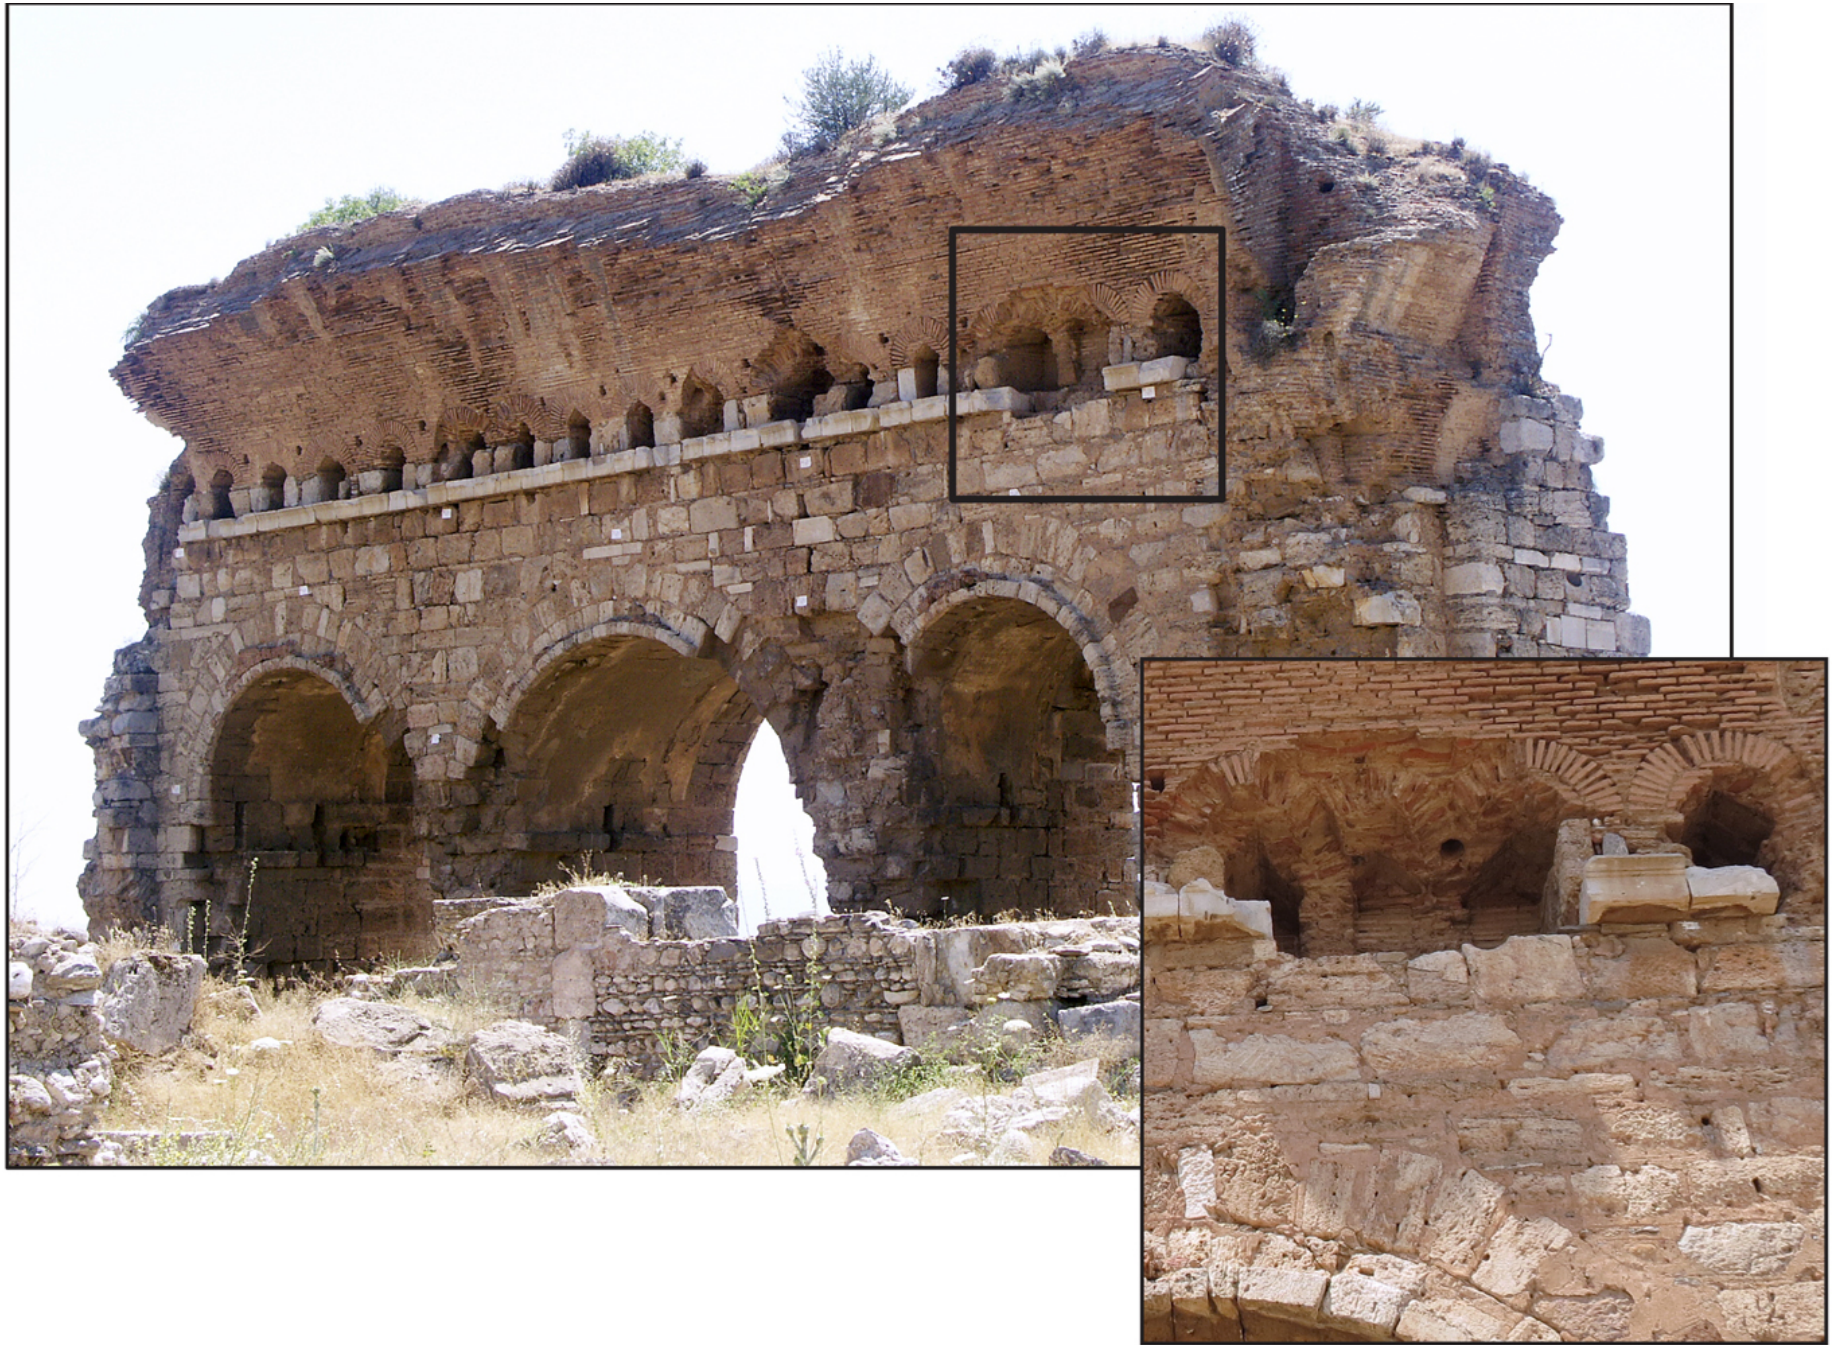
Web Figure 10. Uç Goz Baths at Tralles, Turkey (compare Figure 23B). Lower right: Detail showing the damaged beam holes. Note the vertical exhaust tube between the holes and the projecting ledge running along the intrados of the arch (bottom left), which supported the tiles for the wall heating.

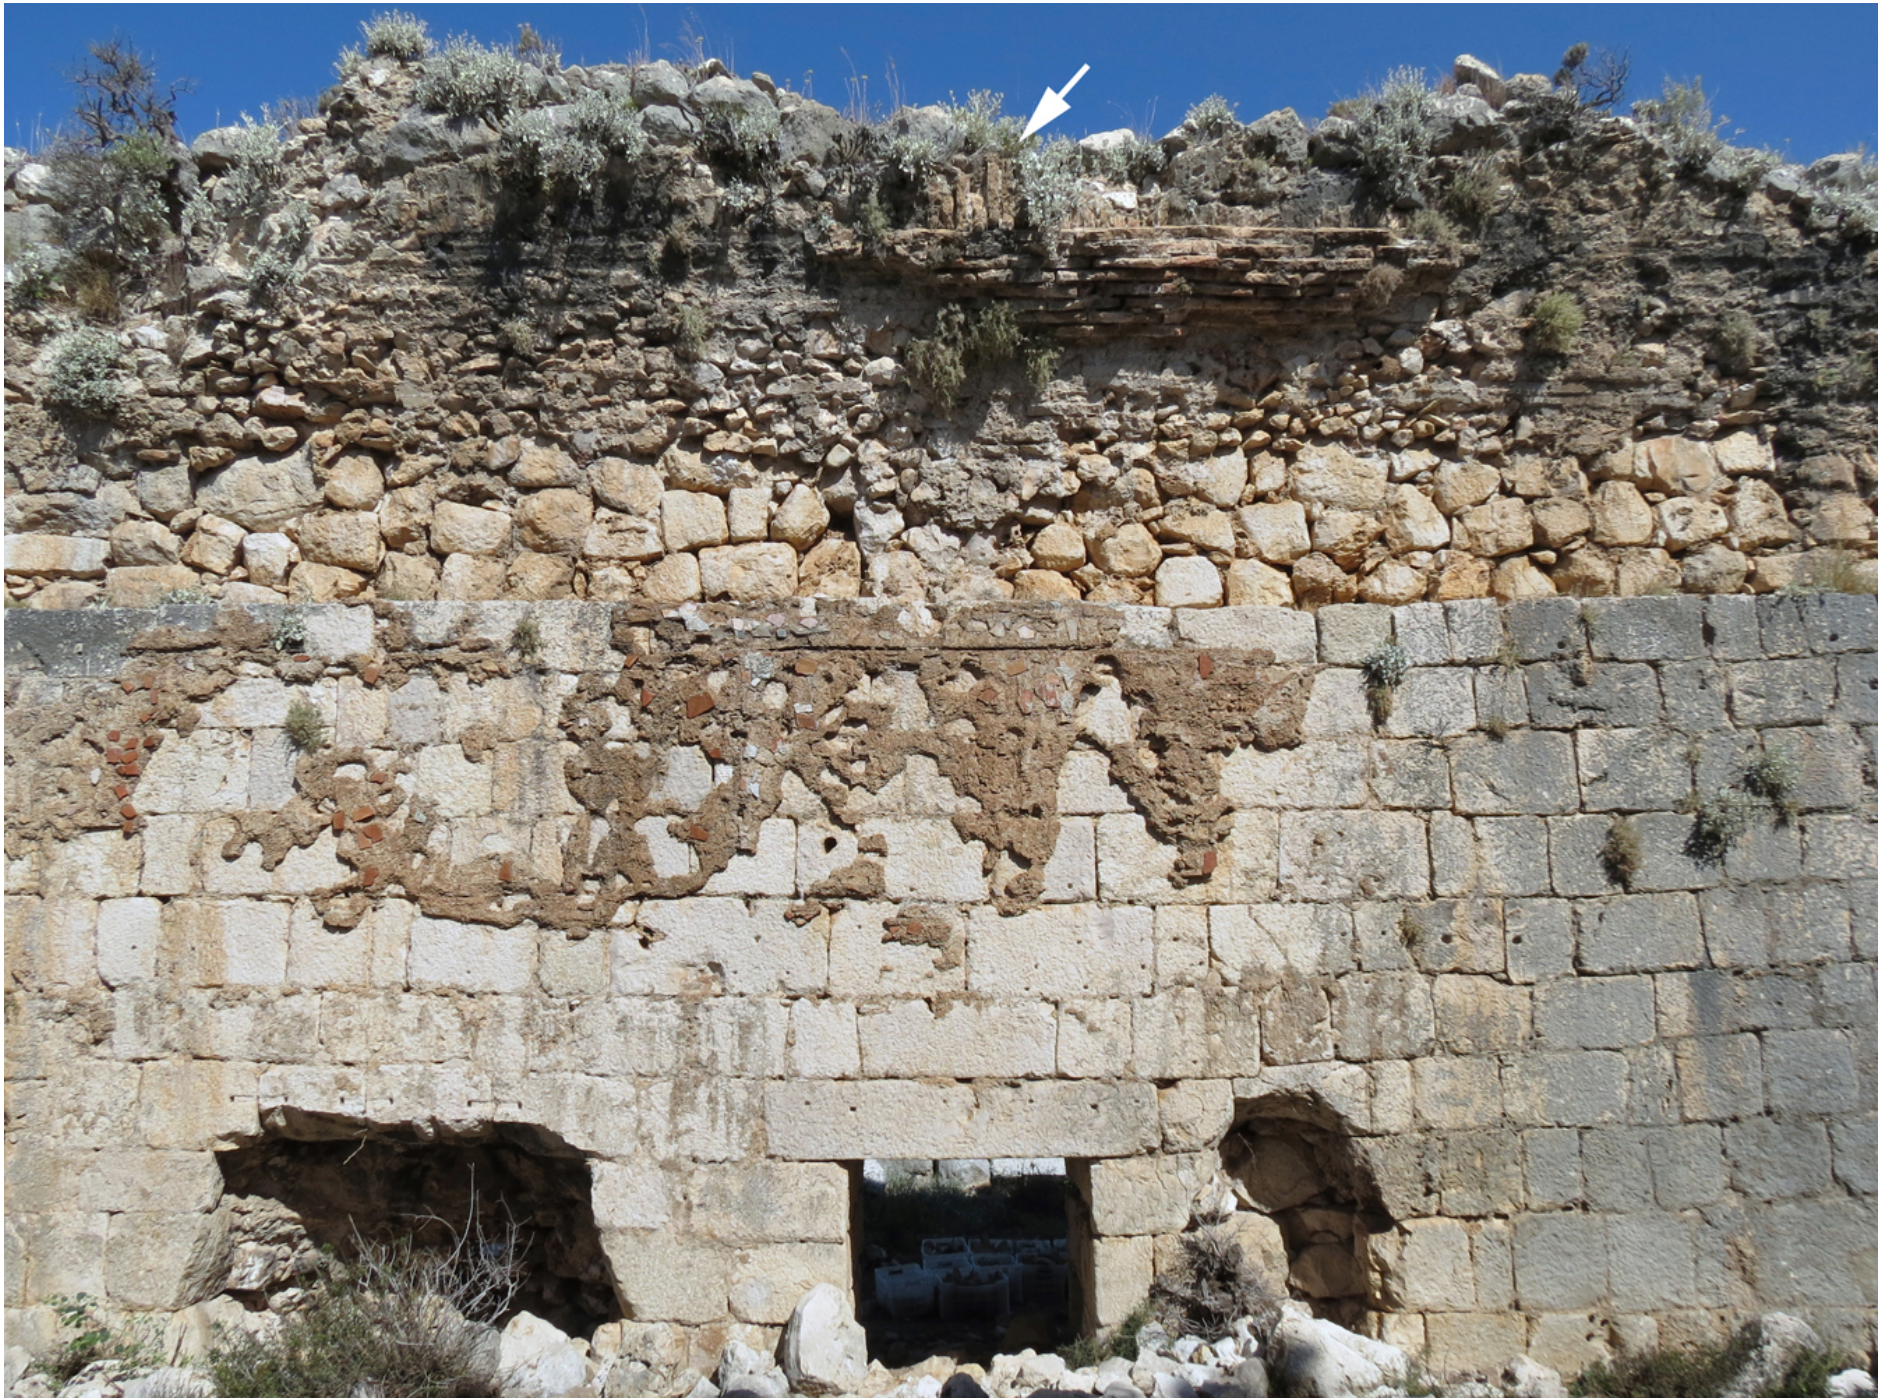
Web Figure 11. Baths of Vespasian at Patara, Turkey (mid-second century CE (?)) (compare Figure 34C). Arrow indicates remains of vertical bricks set above the radial bricks at the haunch.
