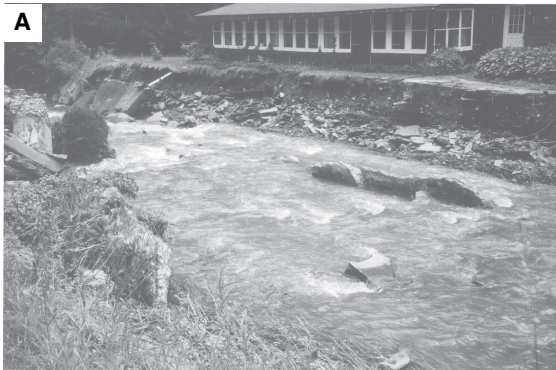
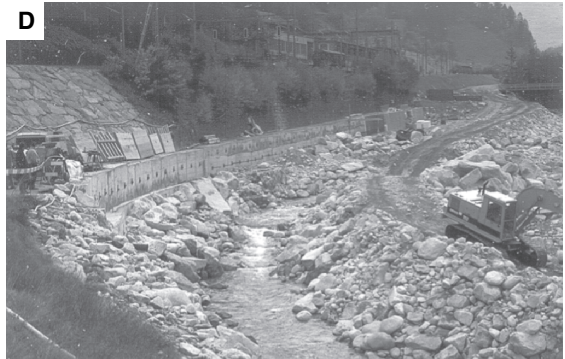
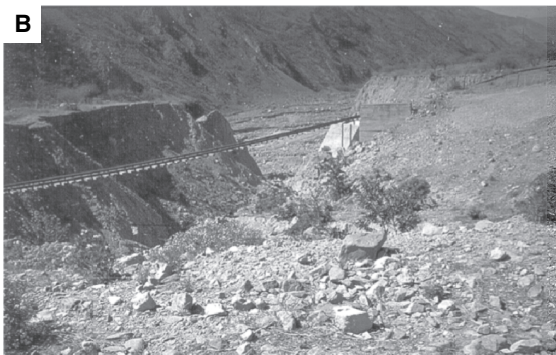
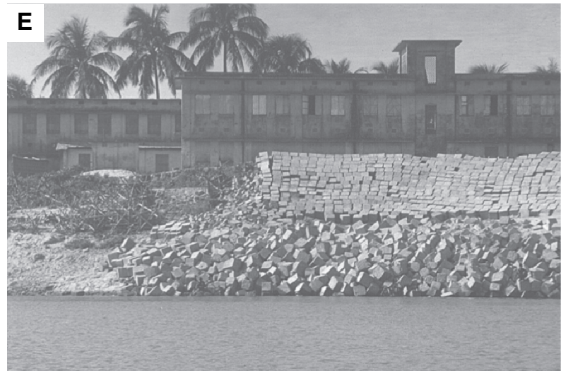
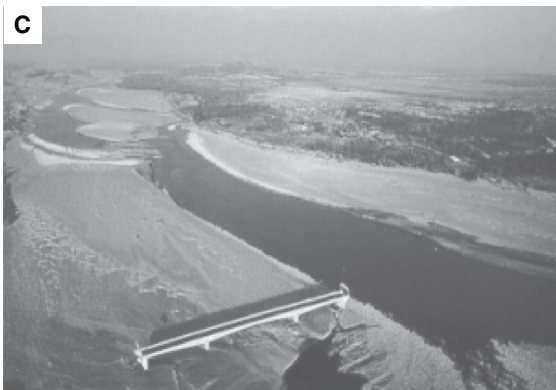
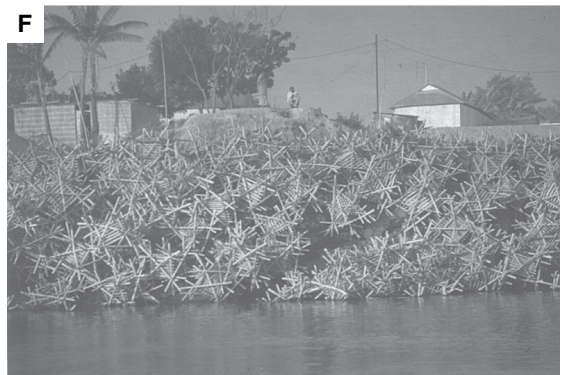
FIGURE 13.33. Bank erosion and human activities. (A) Failed riprap and serious bank erosion along a creek in New York State. Remains of concrete riprap and bridge piers lie in the river. (B) Bank erosion undercutting a railway line in northwest Argentina. (C) River and roads moved during a flood in central America, but this bridge did not. (D) Bank protection on an Alpine river, Switzerland. Images (E) and (F) show riprap along the Brahmaputra River, Bangladesh (photos courtesy of Jim Best). Modified from Bridge (2003).
