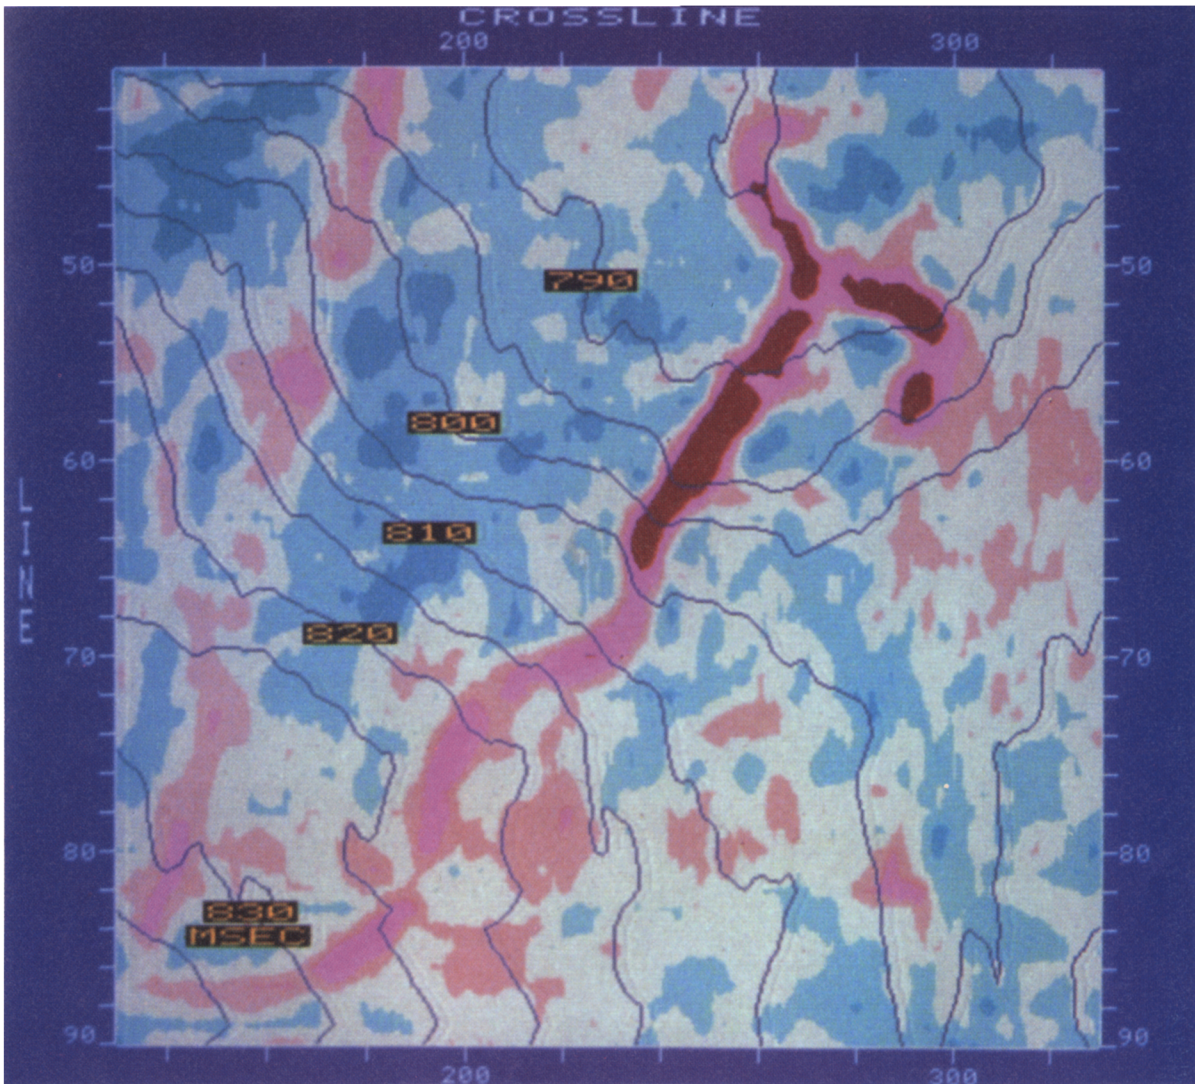
Plate 10 Horizon slice showing a stream channel. The superimposed contours illustrate the structure and the brightness in the high portion of the channel indicates hydrocarbons in a channel sand reservoir. (From Brown, 1985: 123.)

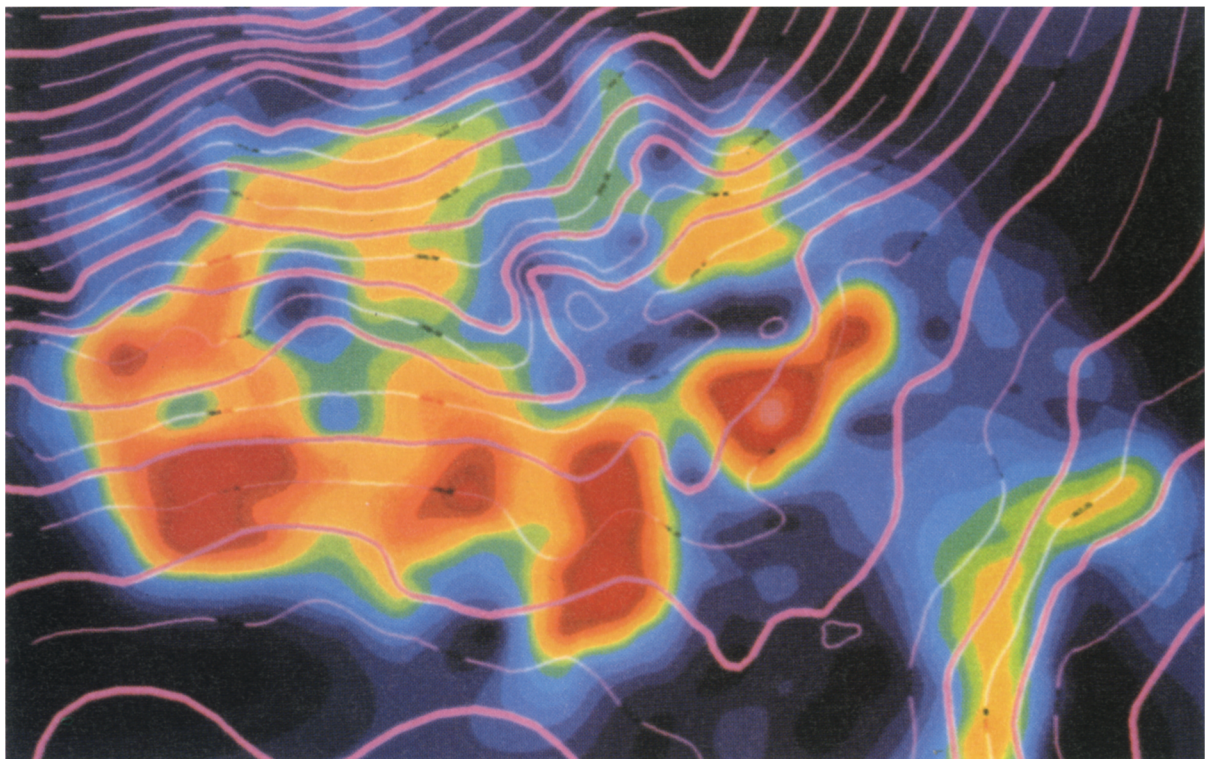
Plate 12 Horizon slice with overlain structural contours showing bright spots indicating stratigraphic hydrocarbon-gas accumulations, in a turbidite fan. (From Brown, 1991: 130.)
